OH-6A TAIL ROTOR TRANSMISSION GREASE EVALUATION AND FAIL DETECTION SYSTEM TEST

B.R. Smith & G. Grigorian
Hughes Helicopter Company
Centinela Ave. at Teale St.
Culver City, CA 90230

~~REDACTED~~ JUN 1977
Final Report

FINAL REPORT
ENGINEERING SERVICES CONTRACT
DELIVERY ORDER NO. 0019
TAIL ROTOR TRANSMISSION GREASE
EVALUATION AND FAIL DETECTION SYSTEM TEST

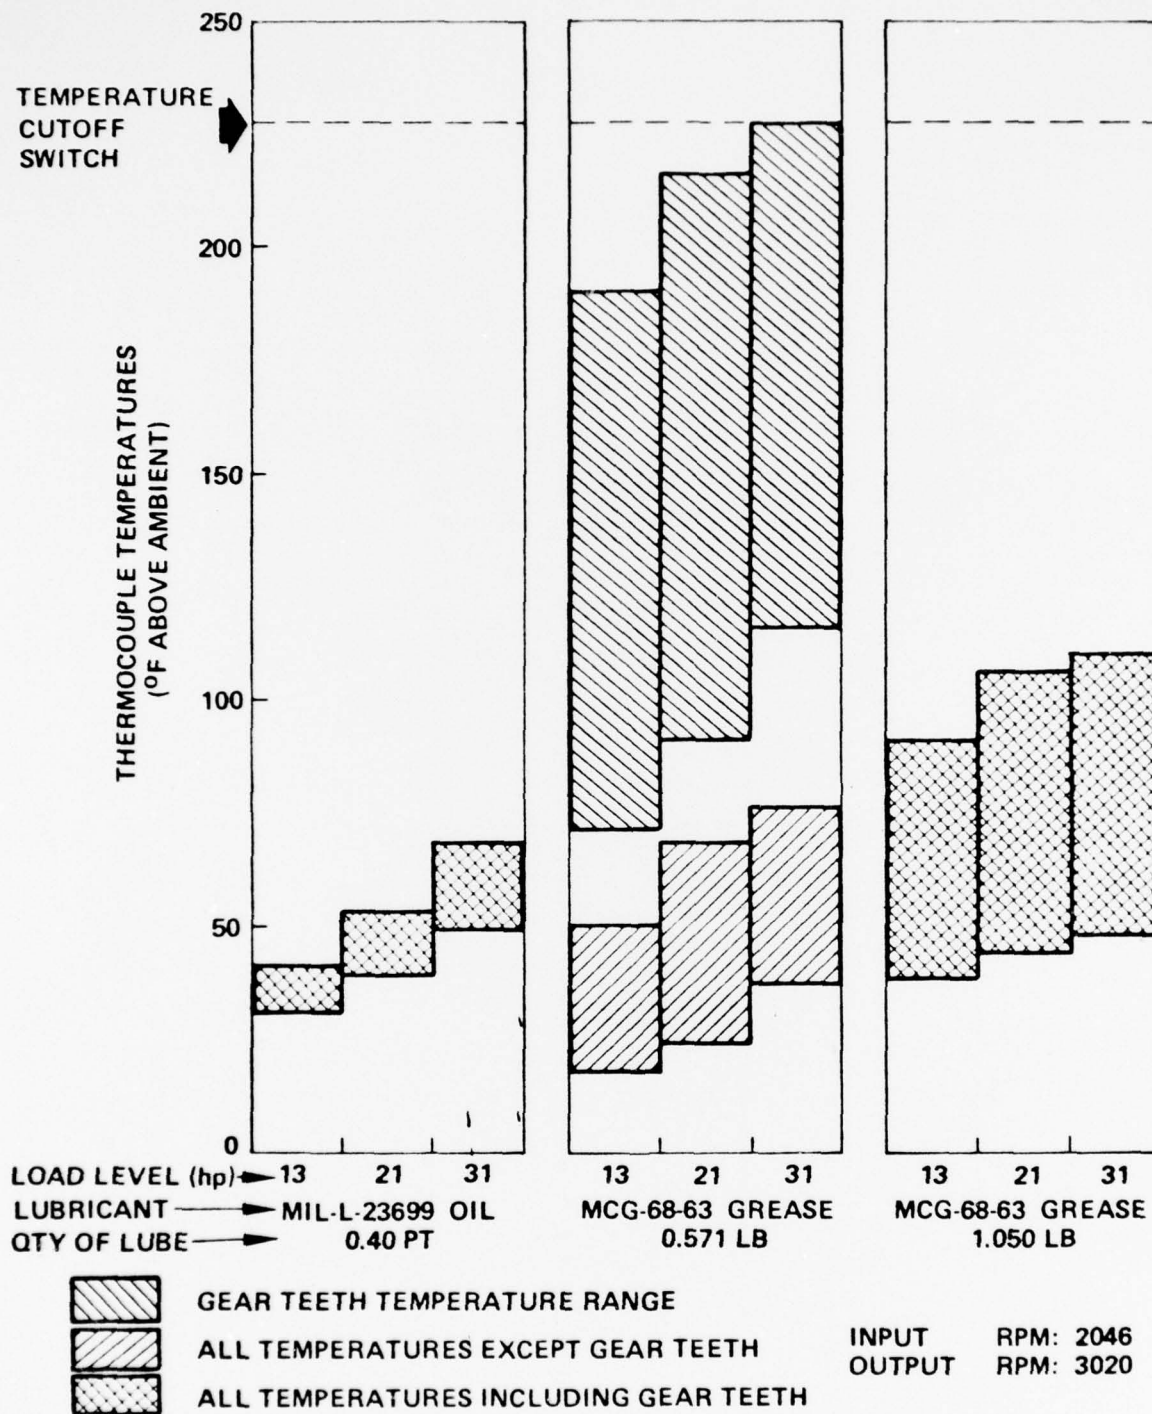
Figure 1. OH-6A Transmission Temperature Comparisons - Grease versus Oil

The OH-58 spectrum load test results were similar to those obtained with the OH-6A transmission, except that the temperature changes were less than those experienced in the OH-6A spectrum load tests. Excessive wear and scoring of the OH-58 transmission gear teeth was noted as a result of the test.

Temperature comparisons of the OH-6A and OH-58 are shown in Figures 1 and 2, respectively. Test results are described in more detail in Appendix A.

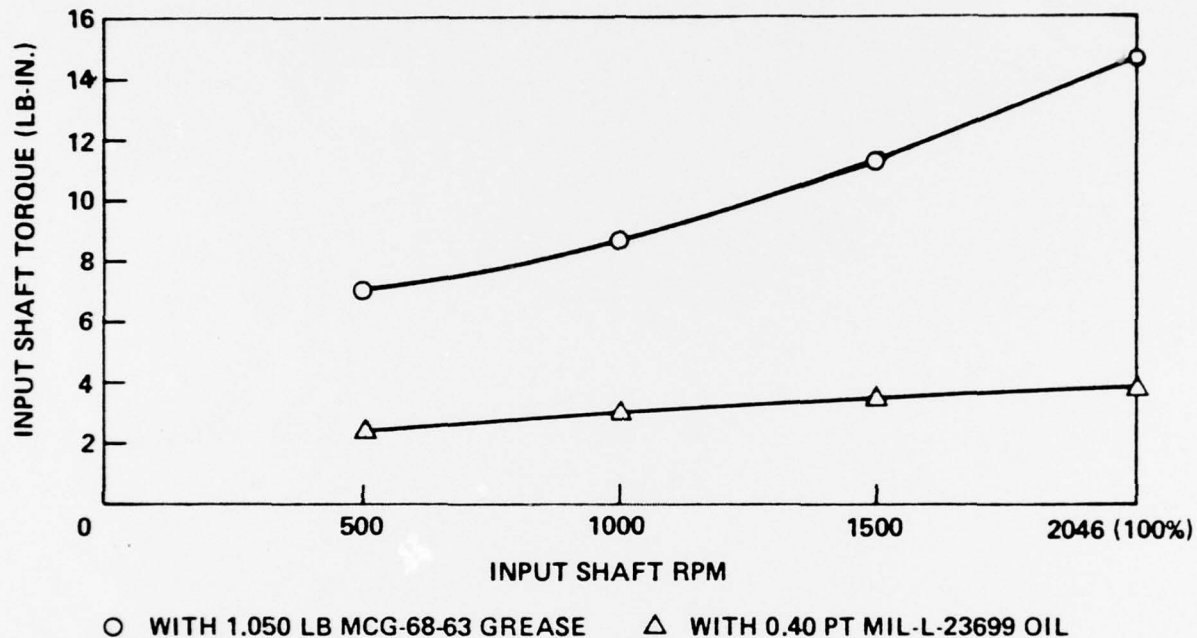
Figure 3. OH-6A Transmission No-Load Dynamic Torque - Grease versus Oil

A no-load dynamic torque test for the OH-6A transmission, filled with grease to 98 percent of capacity, revealed the torque to be approximately four times the value demonstrated when the transmission was filled with oil (Figure 3). Test results are described in detail in Appendix A.

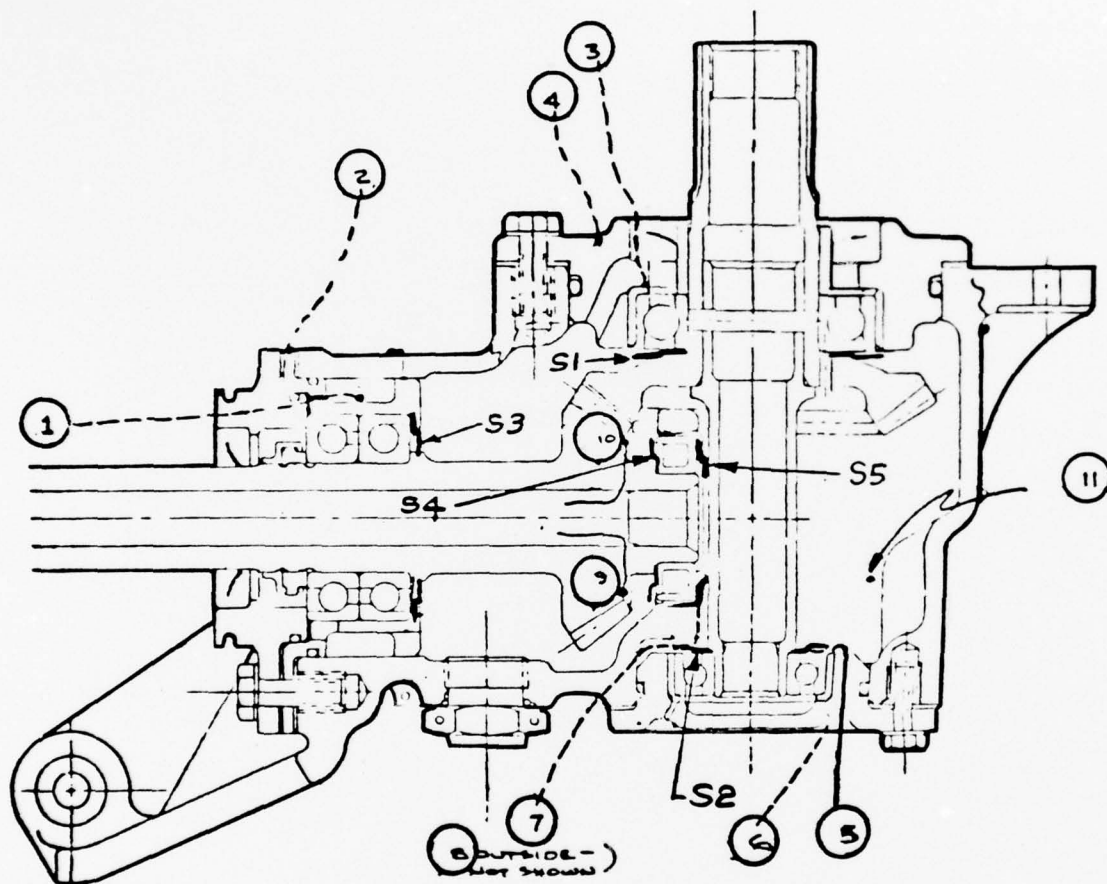
Figure 4. Thermocouple and Shield Locations -
OH-6A Transmission

Thin sheet metal shields required at each bearing are shown in Figures 4 and 5 for the OH-6A and OH-58, respectively. Detail sketches of the shields are in Appendix B. Assembly and disassembly of the OH-58 shields required shop aid tools. Detail drawings are found in Appendix B.

Locations of thermocouples are shown in Figures 4 and 5 for the OH-6A and OH-58, respectively.

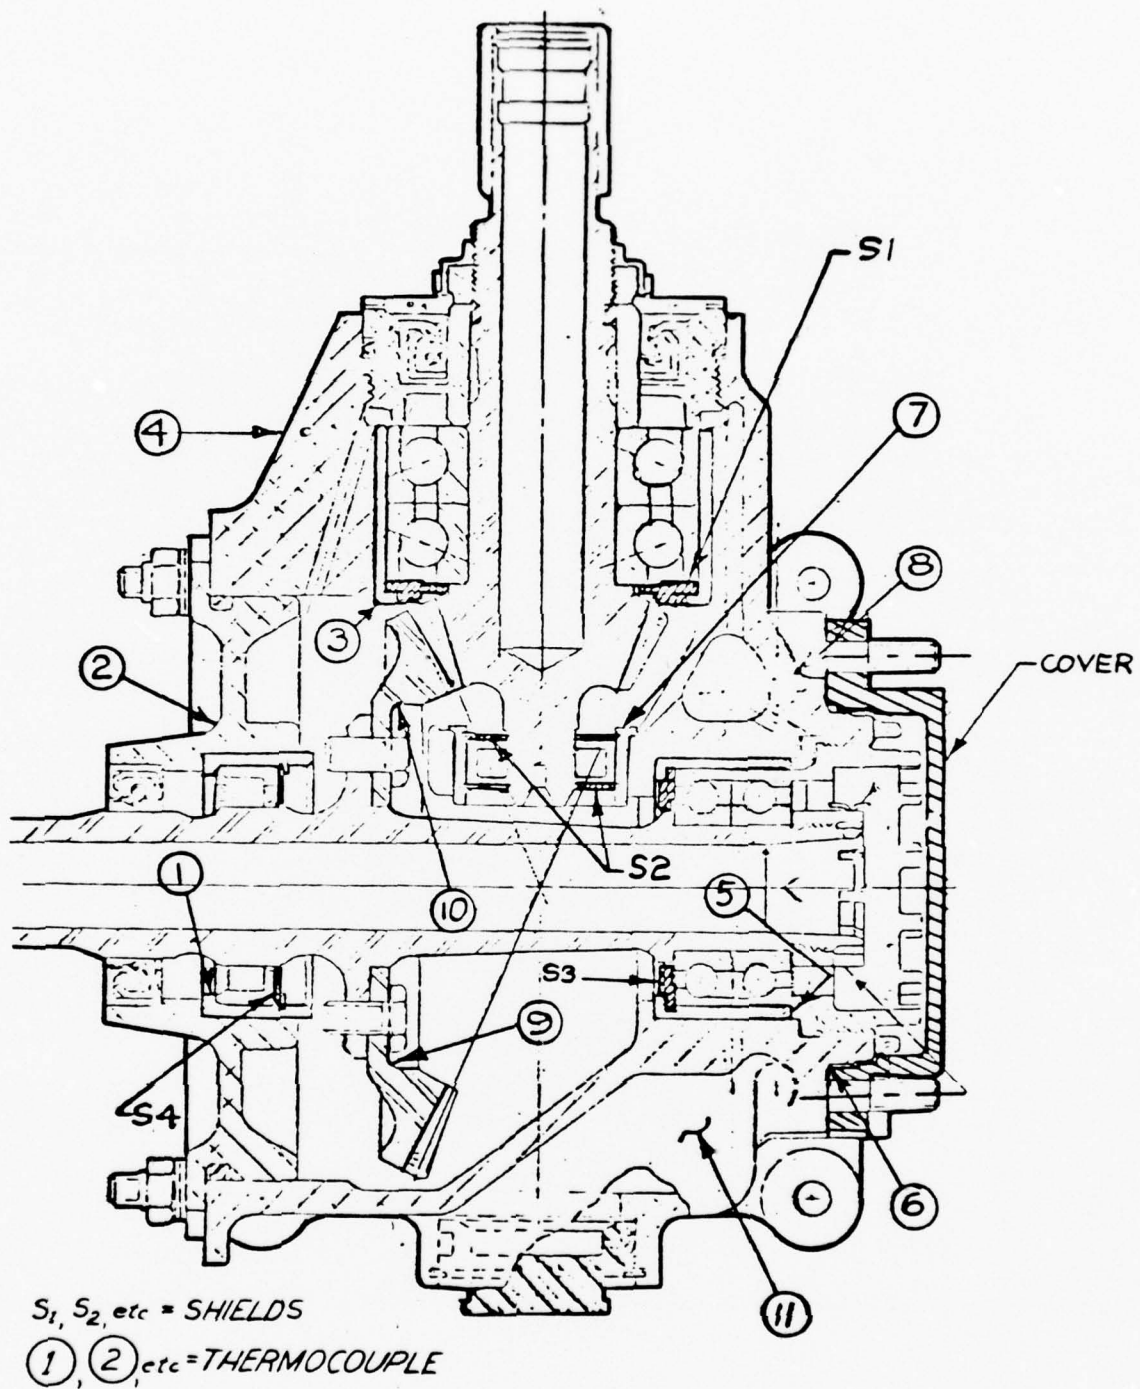
Figure 5. Thermocouple, Shield, and Cover
Locations - OH-58 Transmission

The OH-58 required a cover in order to retain the grease during test. Location of this cover is shown in Figure 5 and the detail drawing is in Appendix B.

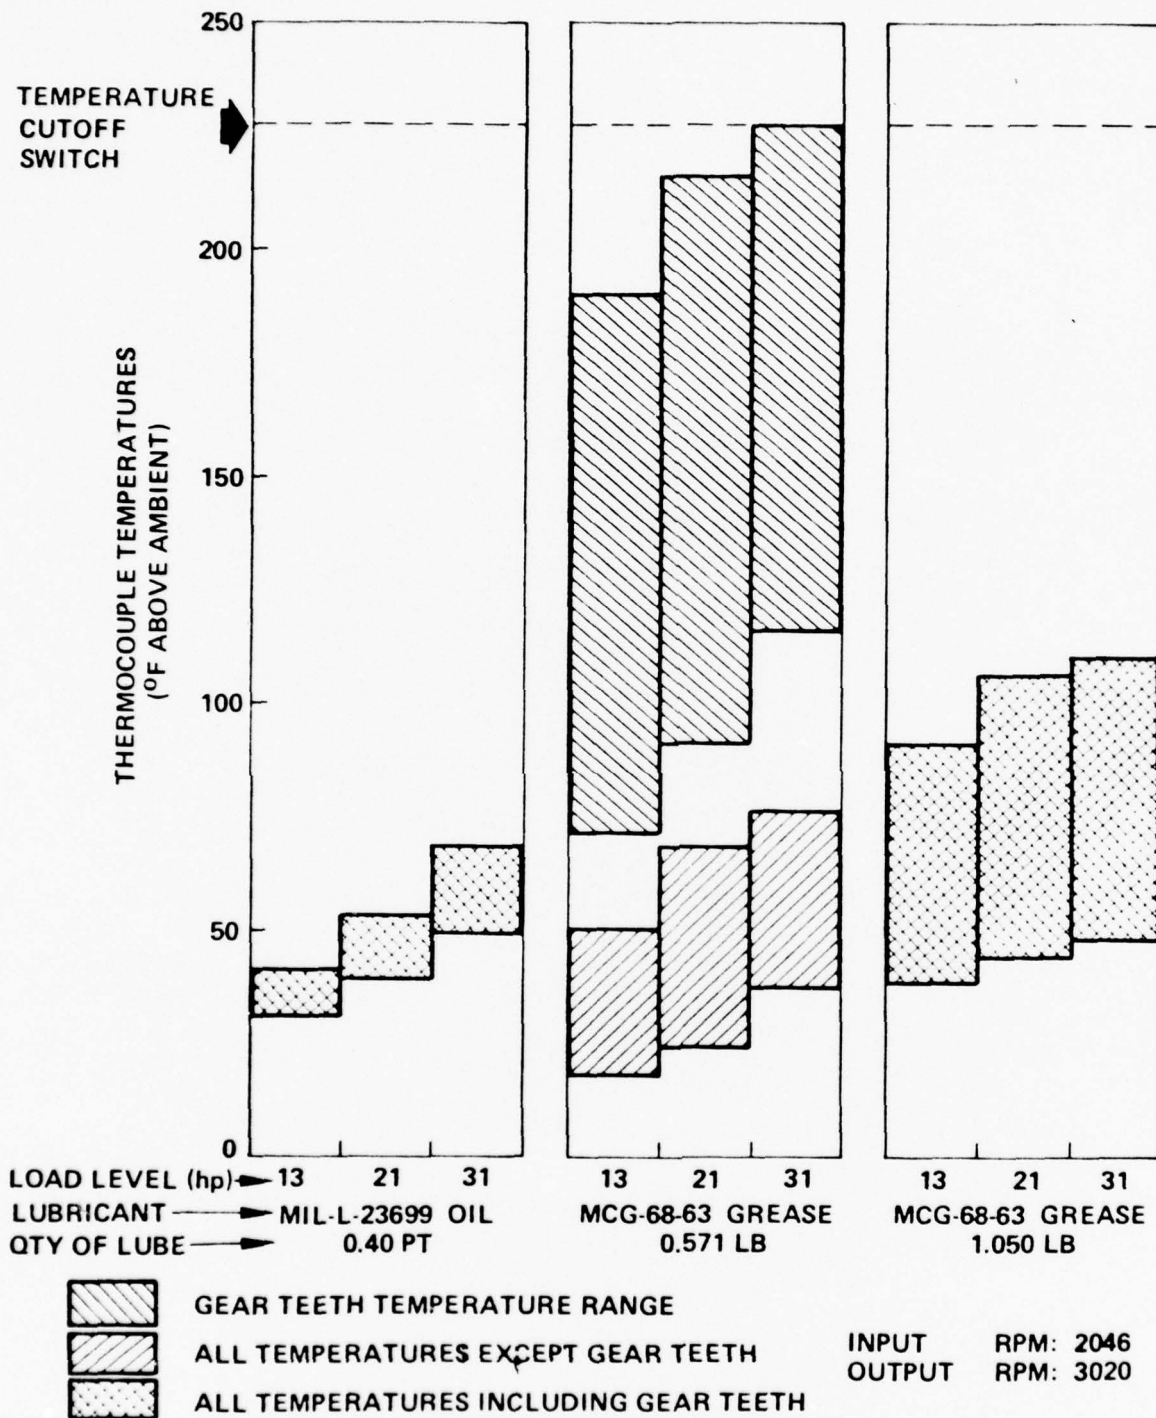
Figure 1. OH-6A Transmission Temperature Comparisons - Grease versus Oil

- #### 3.3.1 OH-6A Transmission - The OH-6A transmissions each containing 0.40 pint of MIL-L-23699 oil, were installed one at a time in the test setup and were run at load levels shown in Figure 1, to obtain the stabilized temperatures for comparison with those of the grease. Air cooling, provided by a large blower, was added to maintain all temperatures lower than 120°F above ambient. Blower speed remained constant (26.5 ft/sec air velocity) for all subsequent testing.

Use of the MCG-68-63 grease as a lubricant resulted in higher temperatures than when tested with MIL-L-23699 oil (see Figure 1).

A marked increase in gear teeth temperatures resulted when the transmission was less than approximately 98 percent full of the grease (see Figure 1).

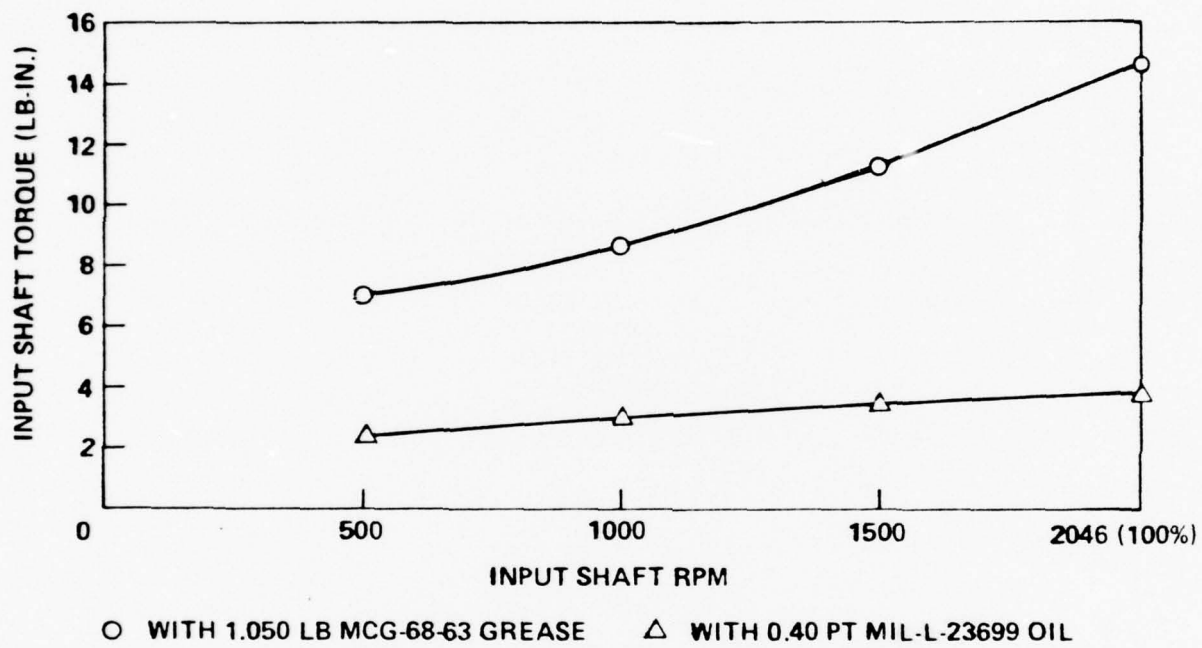
Figure 2. OH-6A Transmission No-Load Dynamic Torque - Grease versus Oil

The second transmission (S/N 883071) was reassembled with 1.050 pounds of the test grease installed and placed in a setup to measure the no-load dynamic torque at the input shaft. Following this, the transmission was cleaned and 0.40 pint of MIL-L-23699 oil was installed and the same procedure repeated. The no-load dynamic torque with grease was approximately four times that obtained with the oil (see Figure 2).

No-load dynamic torque tests with the grease (98 percent full) resulted in values approximately four times those with the oil (see Figure 2).

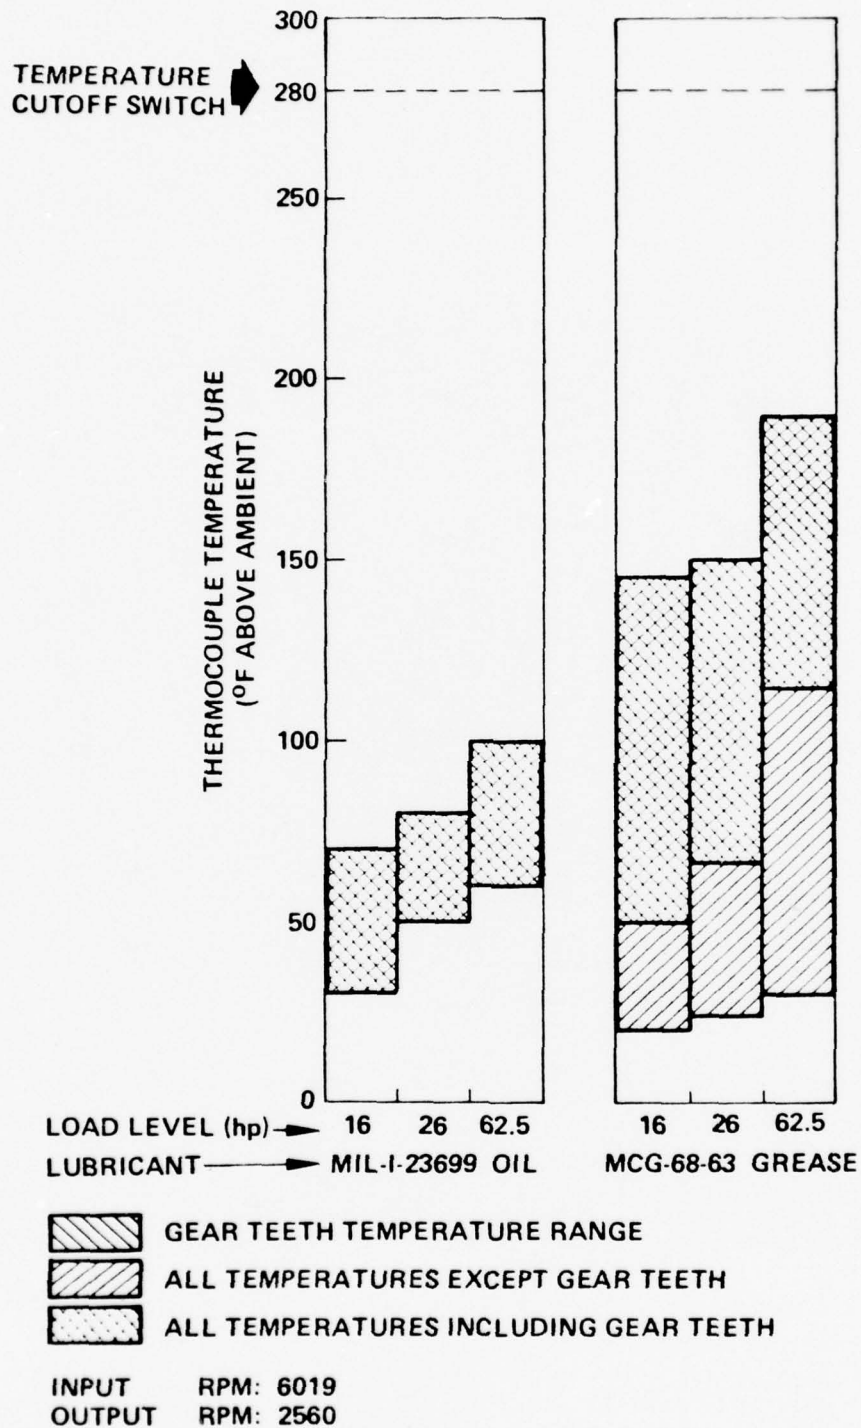
Figure 3. OH-58 Transmission Temperature Comparisons - Grease versus Oil

A 50-hour spectrum load endurance test was commenced with 2.20 pounds of test grease in the transmission. During the endurance test all recorded temperatures, except the gear teeth, varied between 20°F to 160°F above ambient. The gear temperatures varied between 50°F to 190°F above ambient (see Figure 3).

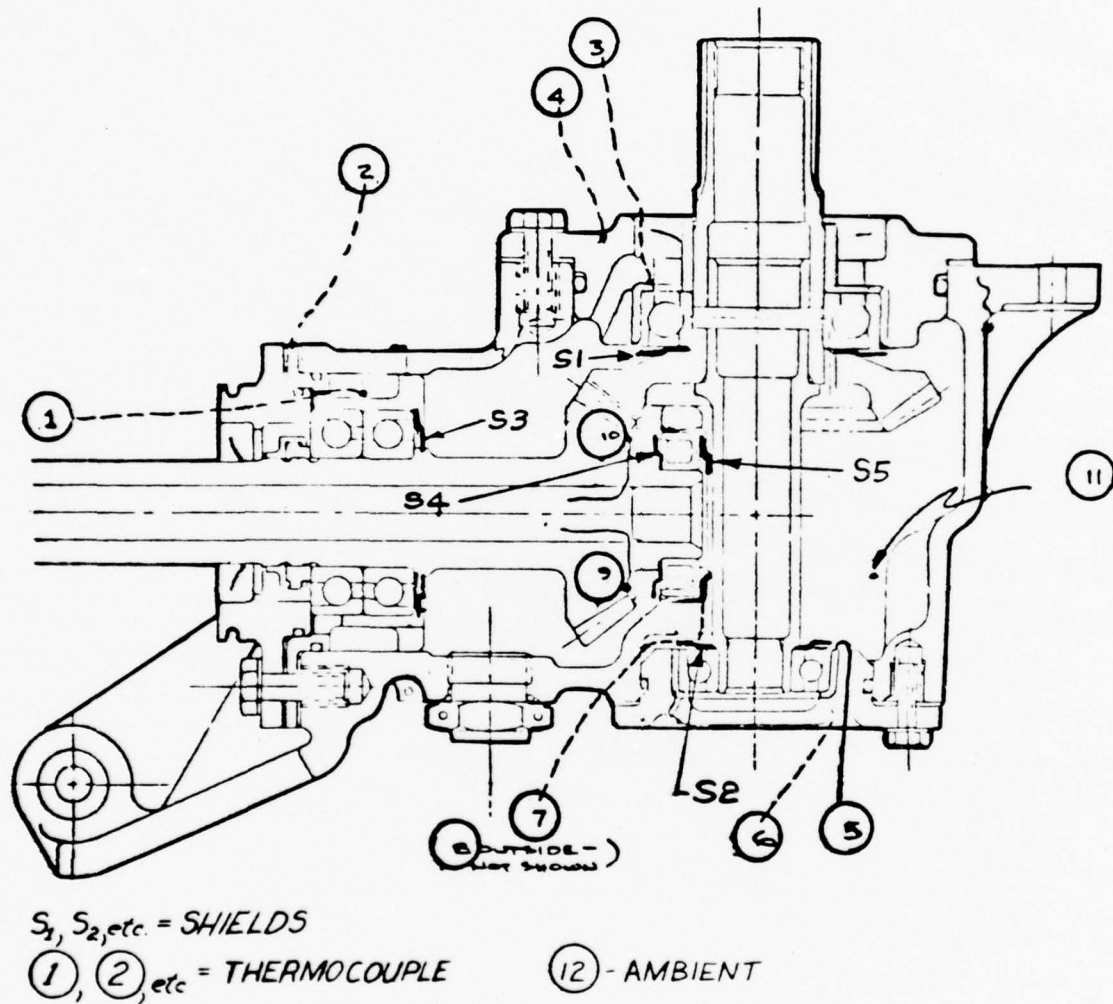
Figure 4. Thermocouple and Shield Locations -
OH-6A Transmission

1. Thin sheet metal shields were installed at each bearing for the grease tests as shown in Figures 4 and 5.
2. Both gears of the 369A5400-601 transmissions were vibro-honed to restore the wear surfaces of the teeth.
3. On all test transmissions thermocouples were installed:
(a) on the inboard end of two teeth of the output gear,
(b) as near to the outer race of each bearing as practical,
(c) on the outside of the housing in the vicinity of each bearing and (d) in the lubricant near the input gear by the drain plug. The thermocouple locations are shown in Figures 4 and 5.

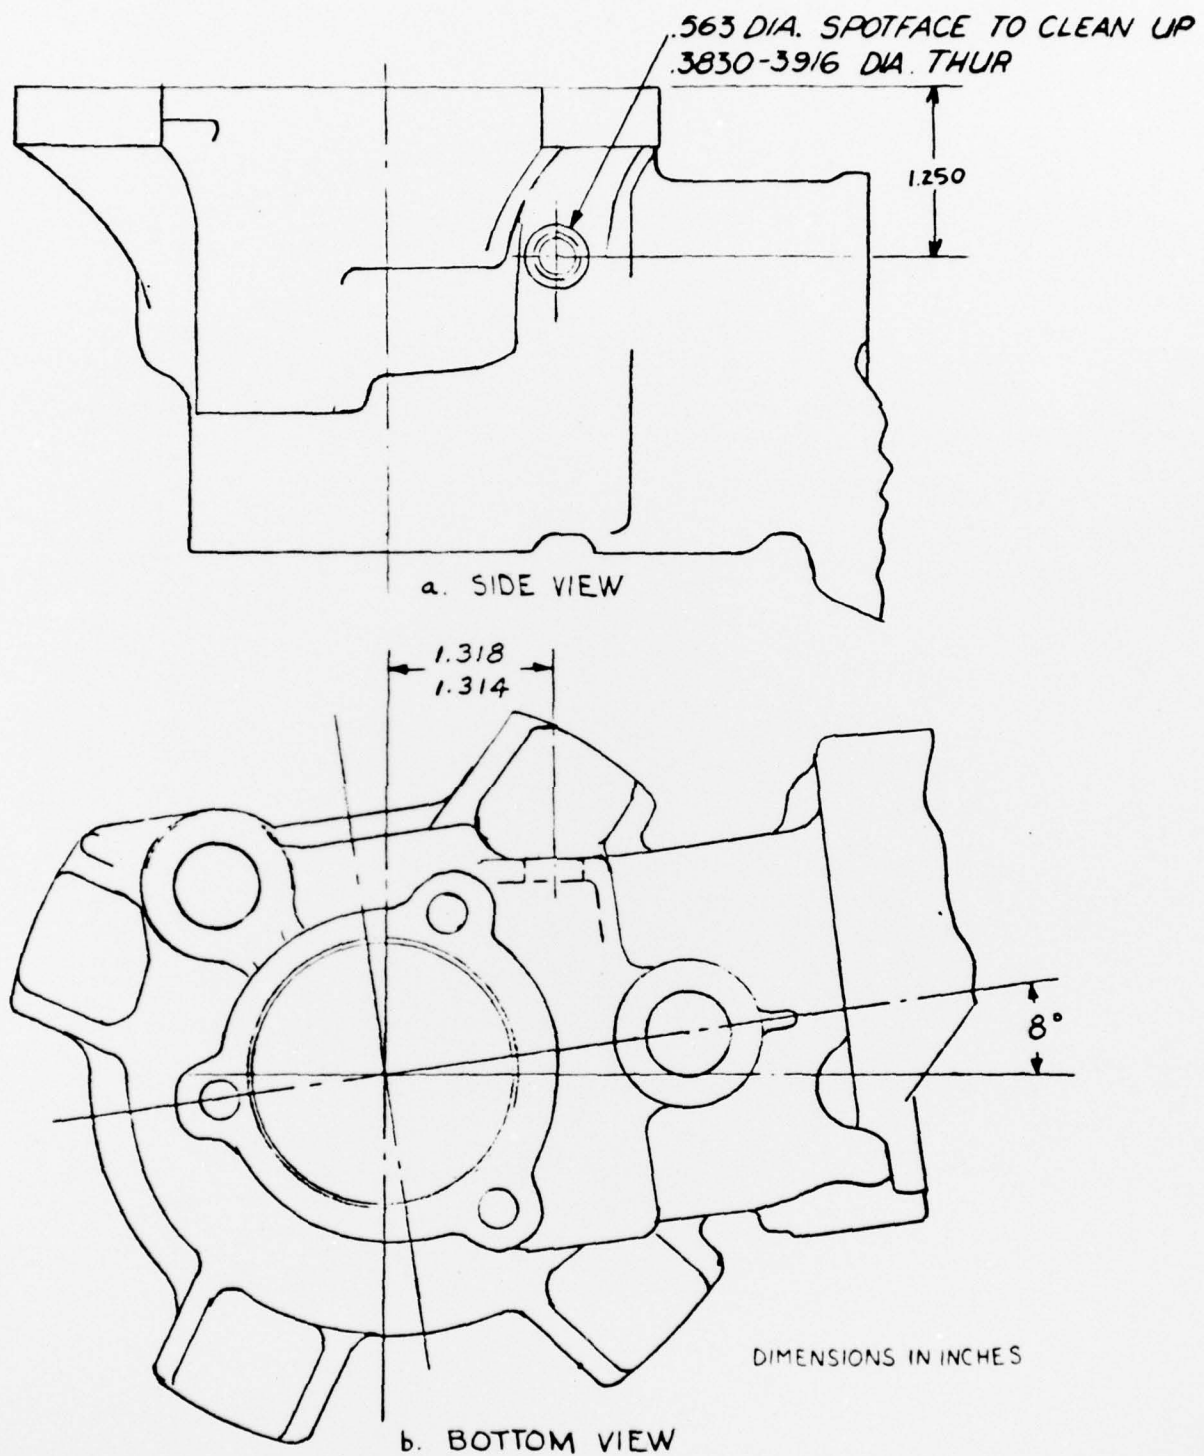
Figure B-14. OH-6A Transmission Housing Modification
Detail for Fail Detection System

Installation of the fail detection system requires modification to the OH-6A transmission housing as shown in detail drawings in Appendix B.
